Re: November 2013 Monthly Progress Report
Administrative Settlement Agreement and Order on Consent for Removal Action
U.S. EPA Region 10 Docket No. CERCLA 10-2009-0255
Gasco Sediments Site within the Portland Harbor Superfund Site

Attachment A Monthly Visual Monitoring Report for Pilot Cap Vicinity

Visual Observations Log Form

Monitoring Period: Monthly (Year 7)—November 2013

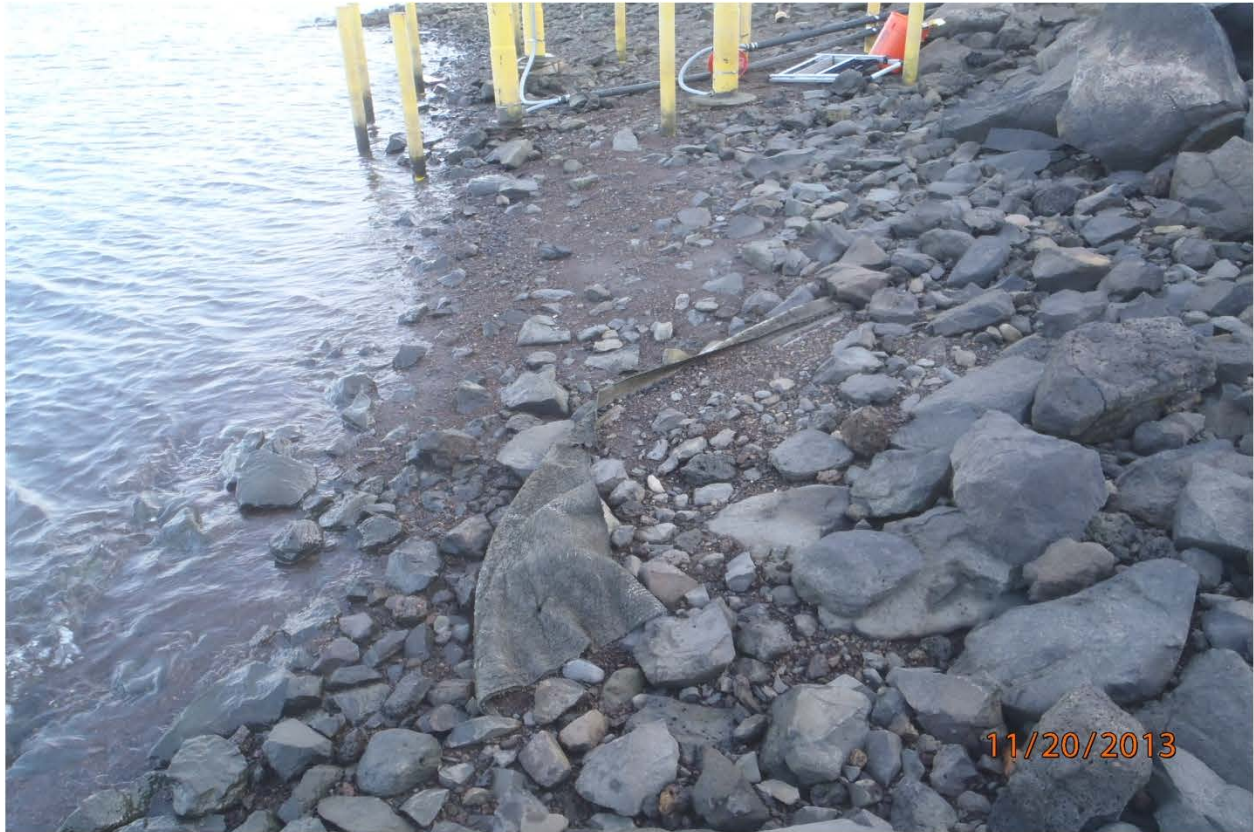
Observations of Erosion/Deposition: No erosion/deposition is evident along the shoreline. Three organoclay mat material segments are exposed and visible. Four feet of a 20-foot section of organoclay mat is out of the water at the upriver extent of the cap area perpendicular to the shoreline. A segment measuring 4-foot in length is 1 to 2 feet from shoreline near the lateral mid-point of the cap area (Photo 1). Near the downriver extent of the cap area, one 40-foot section of organoclay mat material has 3 to 4 feet shoreward of the water's edge.

Photo 1 — *Visible section of organo-clay mat near the lateral midpoint of the cap area (11/20/13):*

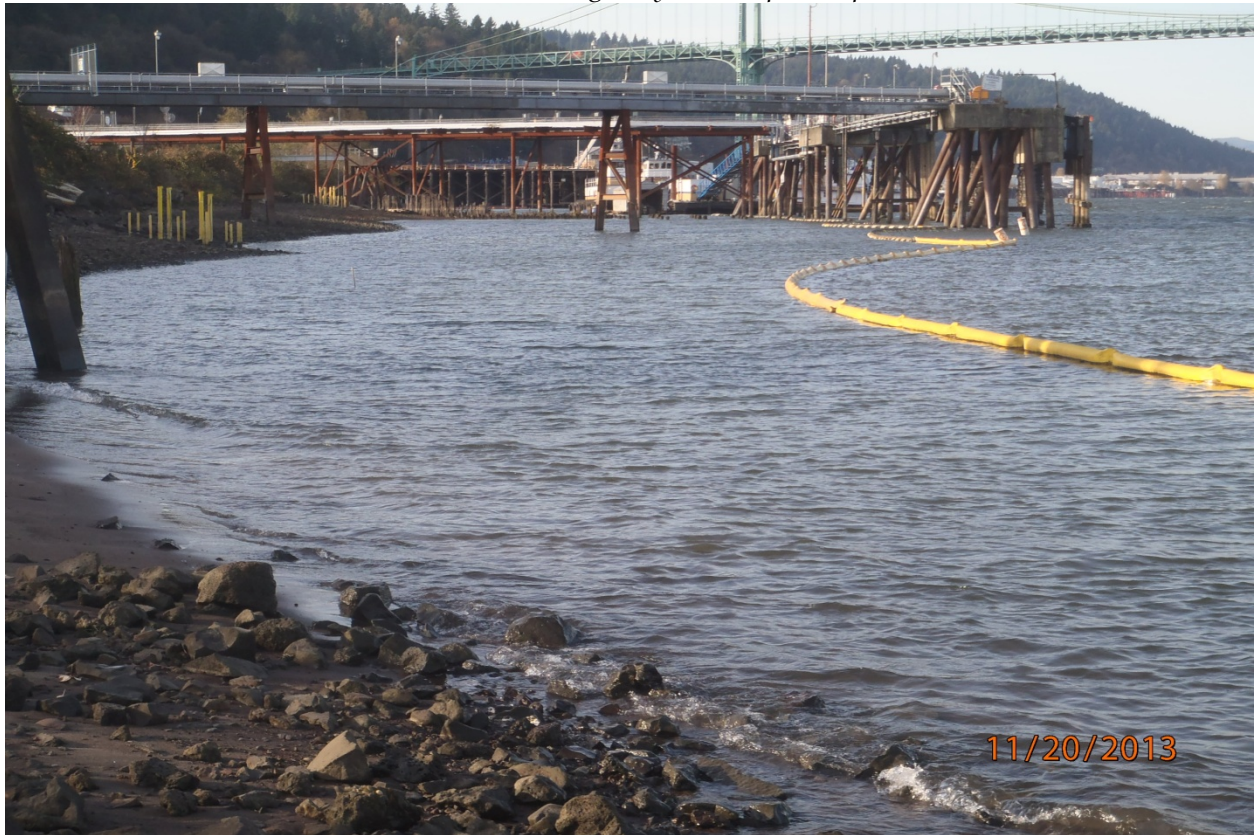
Observations of Long-term Controls (i.e., oil booms, organo-clay mat, etc.) During the observation, the Fuel and Marine Marketing (FAMM) containment boom was placed across the cap area, between the upriver corner of the ship dock and the wooden dolphin (near the upriver extent of the site and near the Siltronic Corporation outfall). Buoys that identify the cap area to mariners are in place as installed. The position of the FAMM oil boom, warning buoys, and a general overview is shown in Photo 2.

Photo 2 — *FAMM oil boom and mariner warning buoys across pilot cap area. (11/20/13):*

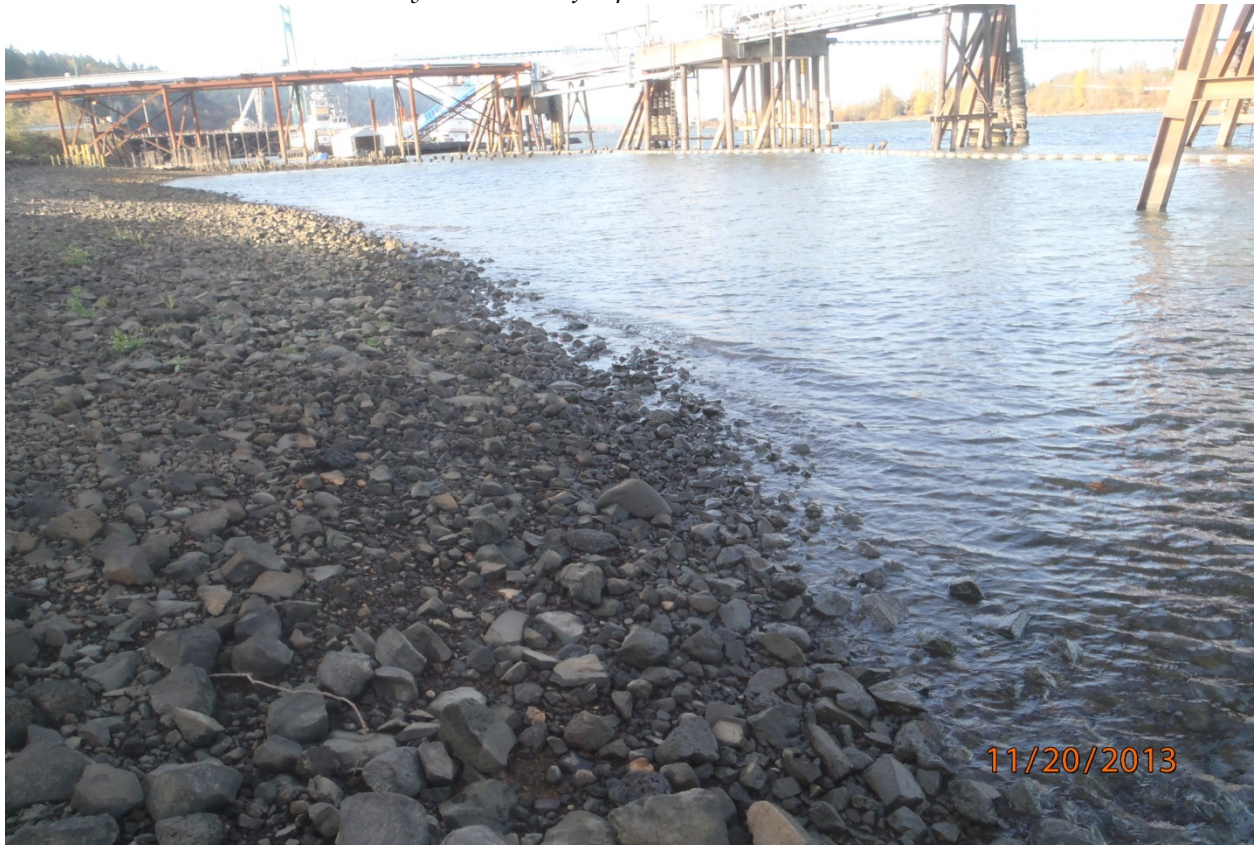
No sheen is evident in or around the cap area. Photo 3 shows the water surface and shoreline immediately downriver of the sediment cap.

Photo 3 — *Conditions immediately downriver of cap area (11/20/13):*
